Manhole Inspection Summary

Manhole # S53AA_041MH

Record Plat: **53AA** Node: **041** Status: **New Manhole (Not in GIS)** Insp Date: **8/18/09 12:00 AM**

Location Address: **523 N.Clinton St.**

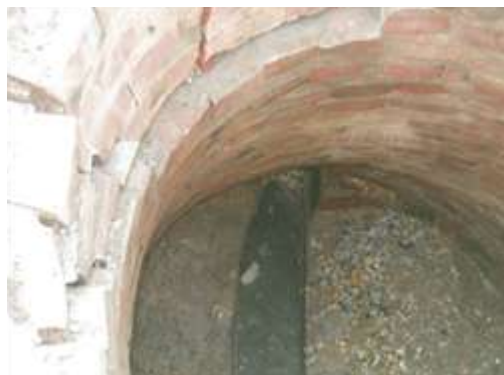
Top View

Egress at 12 is less than desirable

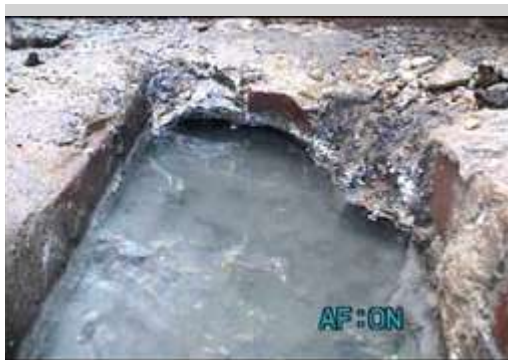
Defect 6

Condition: ☐ Sound ☐ Cracked ☐ Root Intrusion ☐ Deteriorated ☐ Leaks ☒ **Debris**

Channel Debris

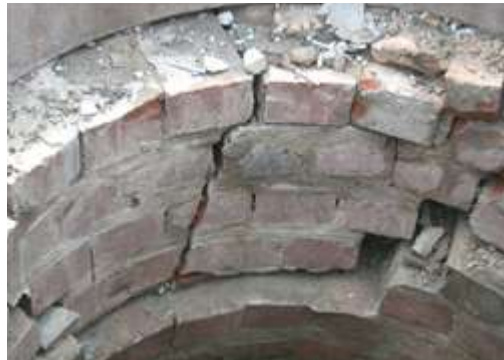
Defect 3

Condition: ☐ Sound ☒ **Cracked** ☐ Root Intrusion ☒ **Loose Brick** ☒ **Deteriorated**

chimney cracked & deteriorated with loose brick

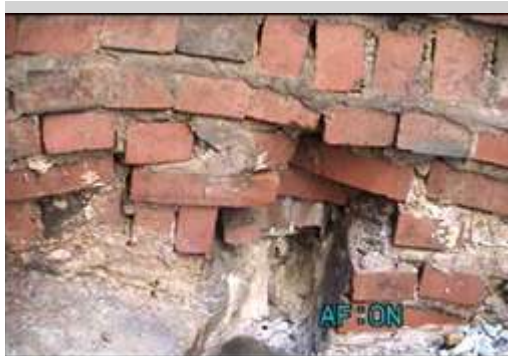
Defect 2

Condition: ☐ Sound ☐ Cracked ☐ Root Intrusion ☒ **Loose Brick** ☒ **Deteriorated**

barrel deteriorated with loose brick

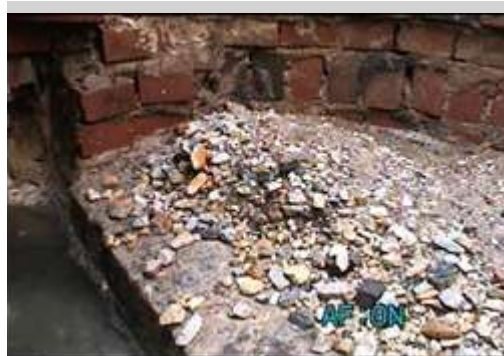
Defect 1

debris on bench

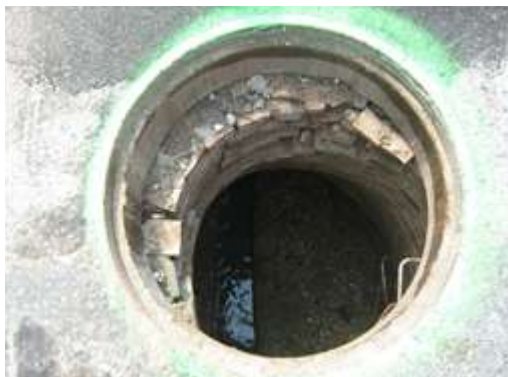
Defect 4

Offset: **5** (in.)

frame offset
